**Forensic Building Science, Inc.**

# Fire Damage Report

**The Metropolitan**

2700 7th Avenue South, Birmingham, AL 35233

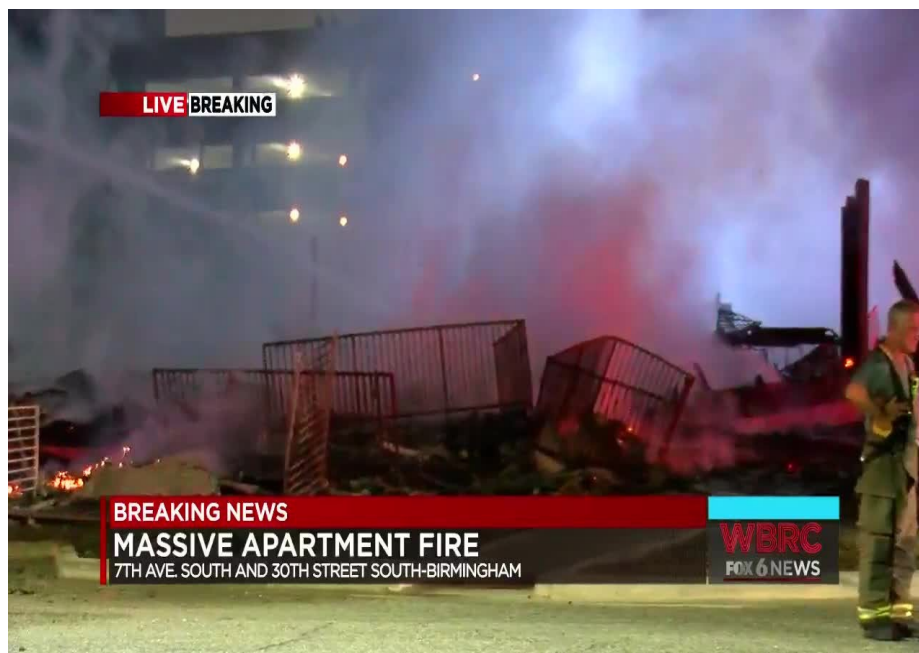
Figure 4: Free-standing building burned to the ground by early morning.

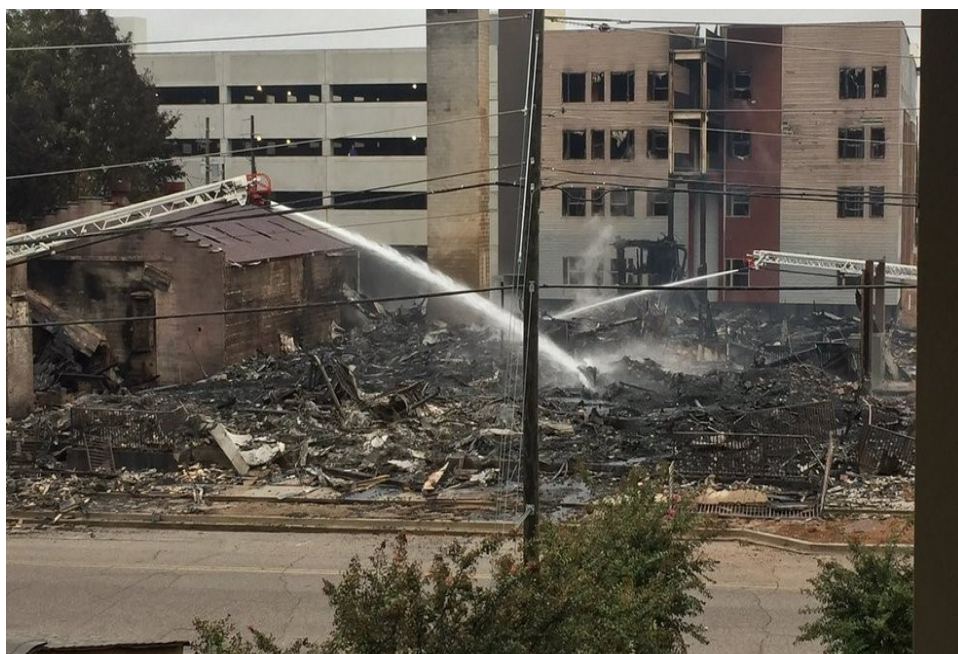
Figure 5: View of the free-standing building burned to the ground by morning. Notice the fire, smoke, and soot damage to the remaining building.

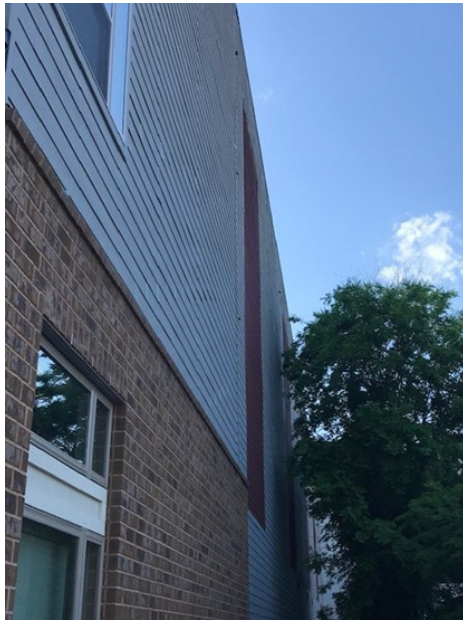
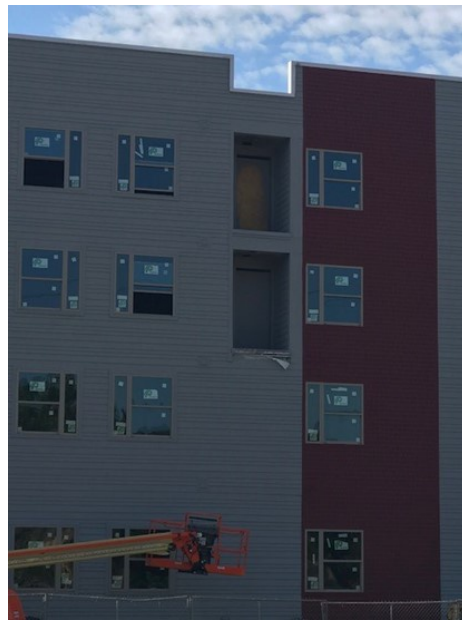
Two exterior sides directly facing Phase 6 that burned down. There is visible bulging in the exterior wall assemblies; furthermore, the manufacturer is requiring that all the siding be replaced, and underlayment inspected for viable reuse.

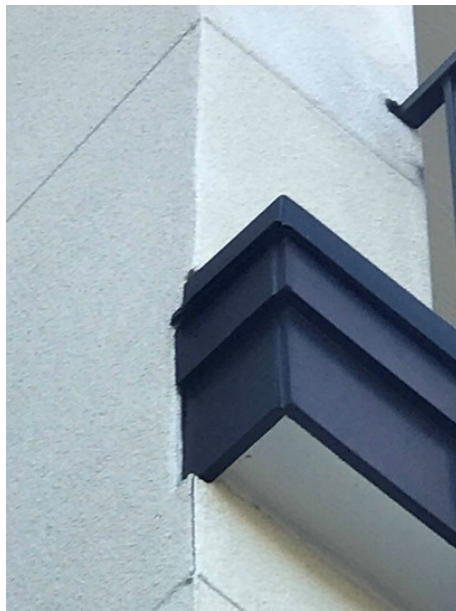
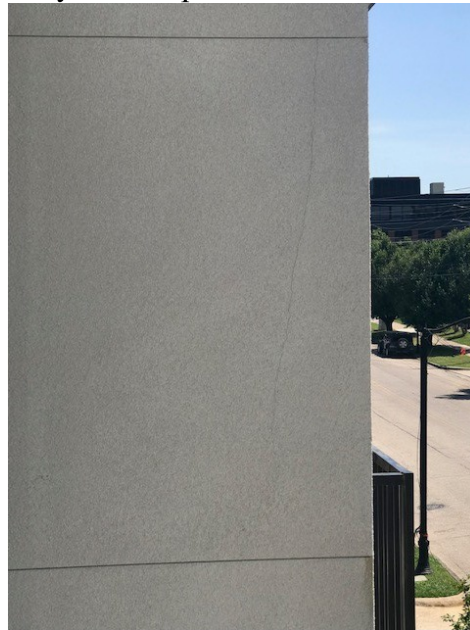
Exterior EIFS is cracking through corners and panels indicating significant water intrusion, followed by expansion and contraction cracking. The EIFS must be removed, the drainage plane restored, and EIFS reapplied to achieve a pre-loss condition.

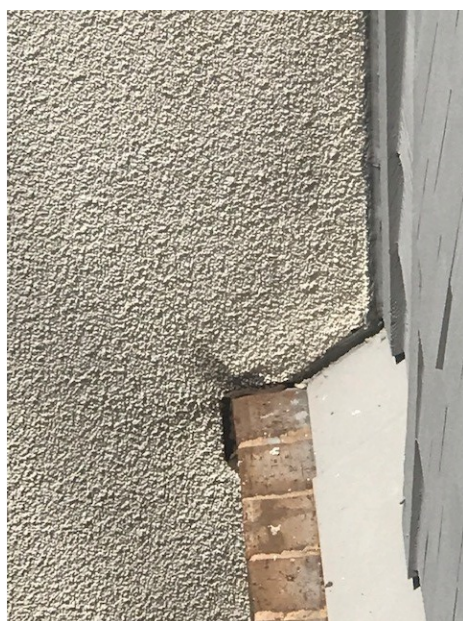
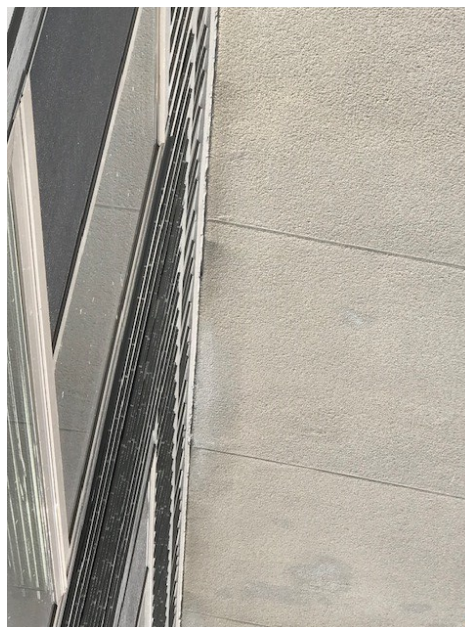
Repairs to flashing show missing flashing, and evidence of water damage that would require removal and replacement.

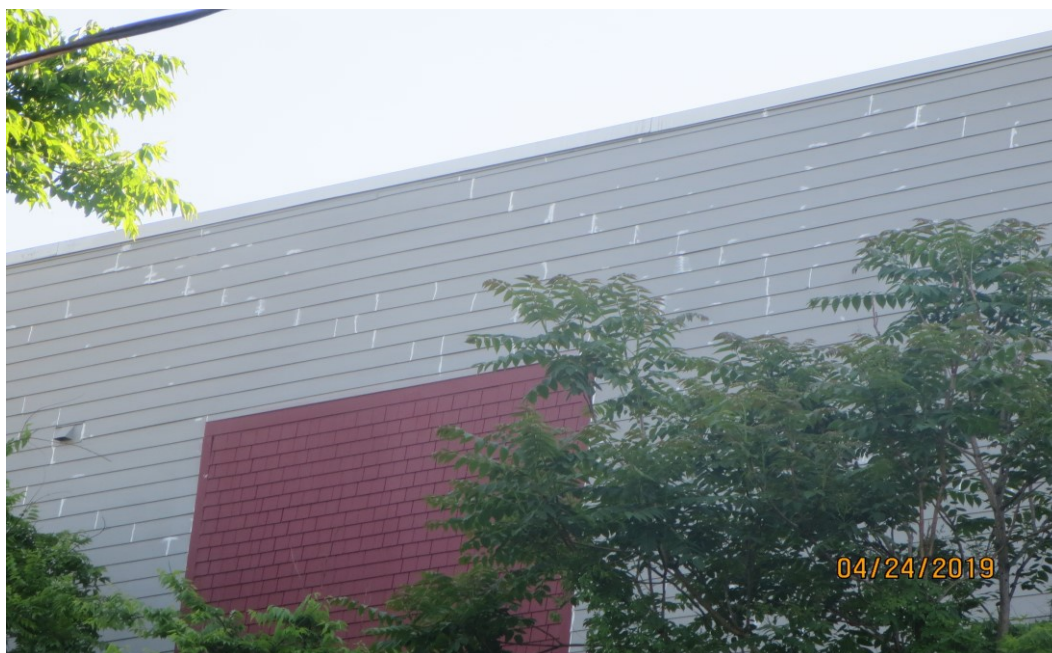
Damaged exterior siding needs to be replaced

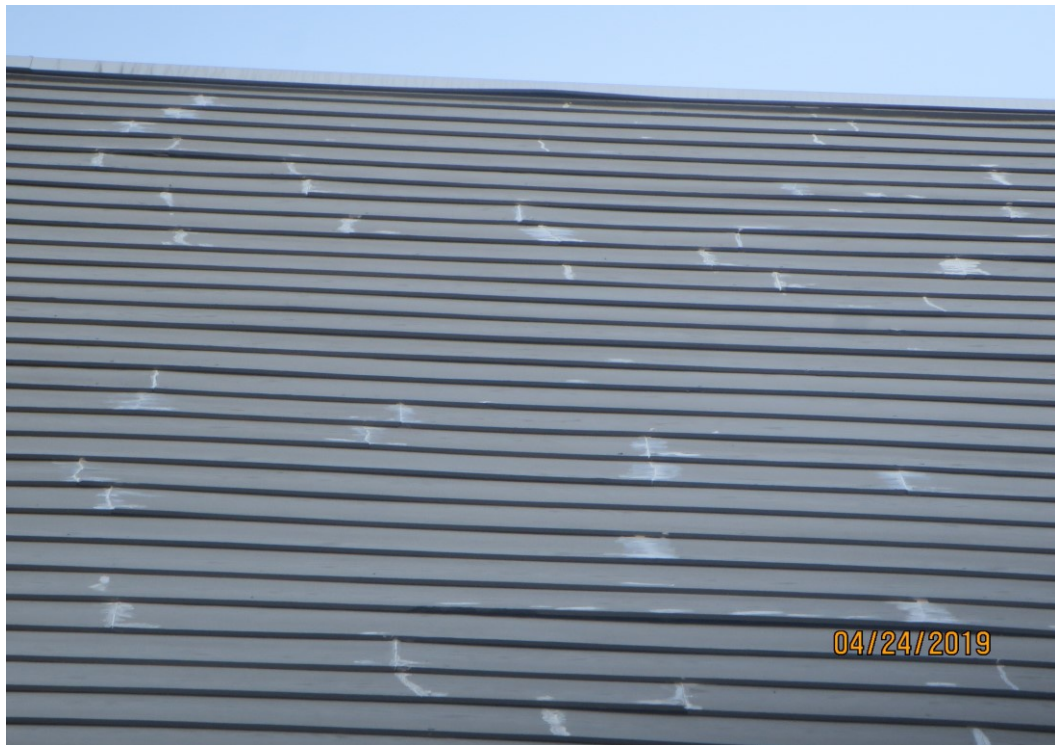
Siding separated and bowed away from substrate after fire and exposure to heat.

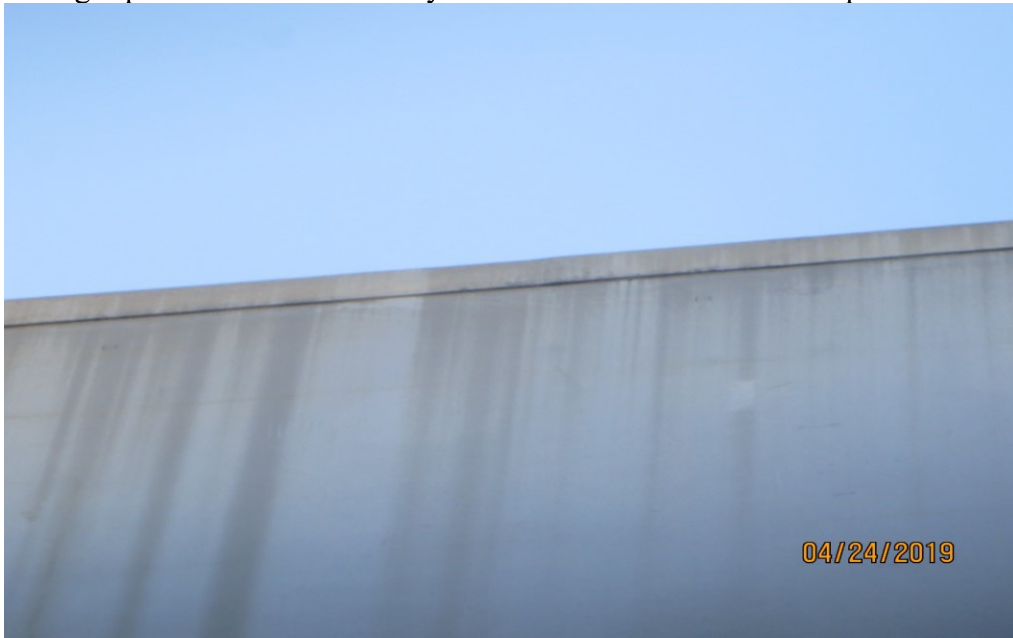
Smoke damaged EIFS needs to be cleaned and repainted.

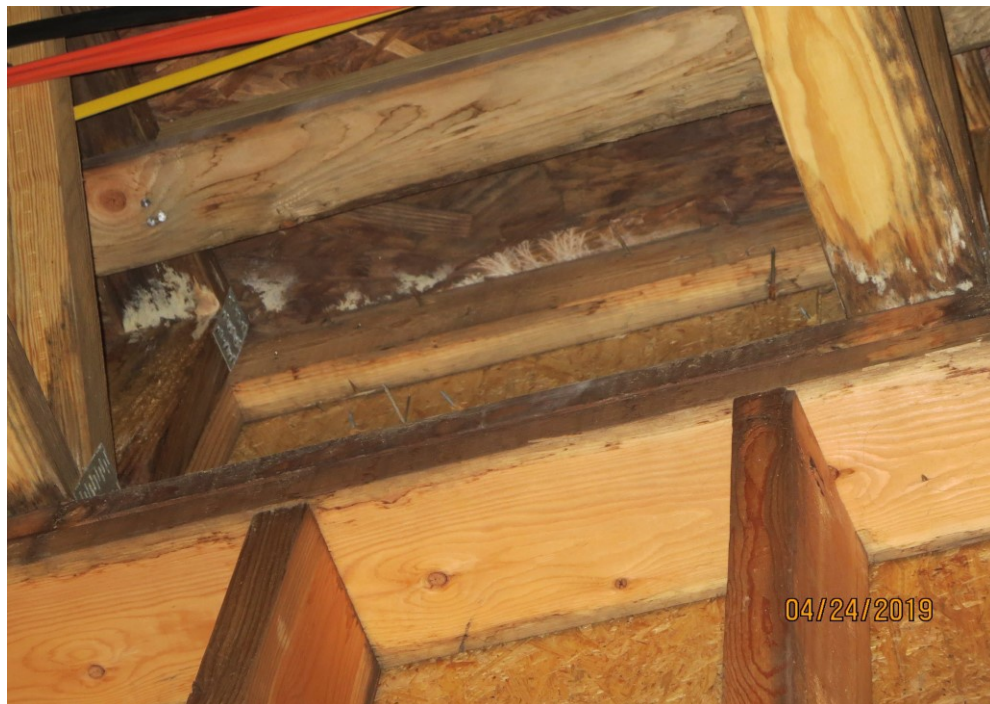
Water damage, smoke and soot contamination in the framing of Phase 4.

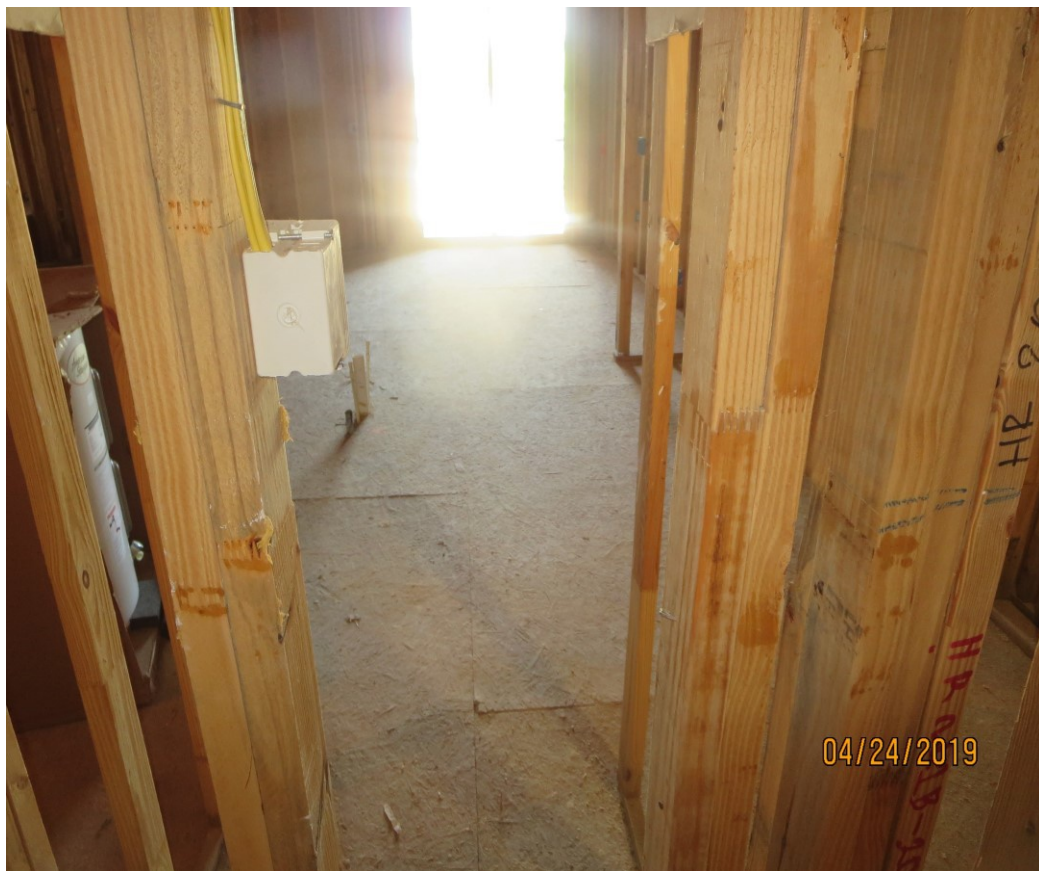
Typical subfloor water damage in phase 5 requiring full replacement

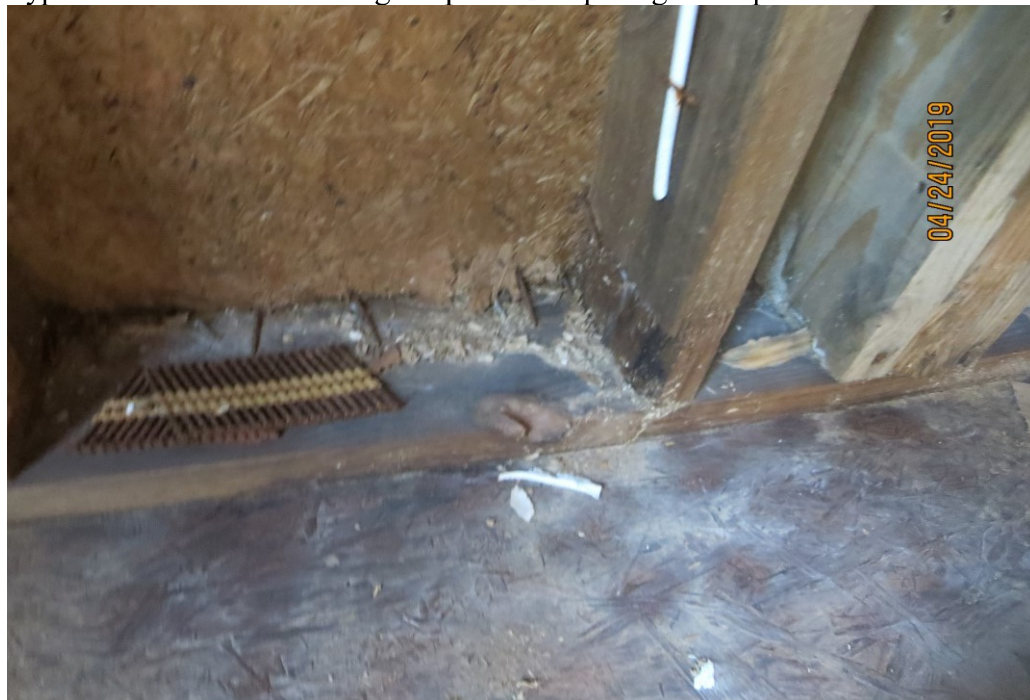
Typical water damage, soot and smoke damage Phase 5

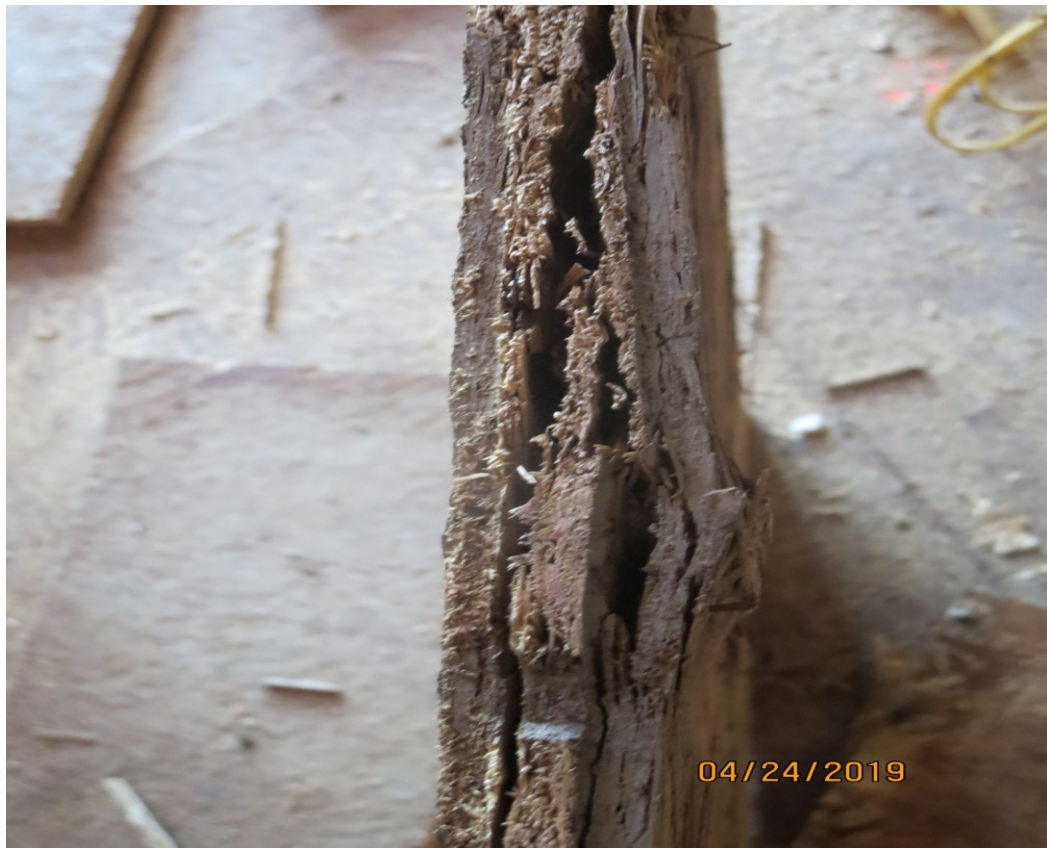
Side profile of water damaged subfloor Phase 5

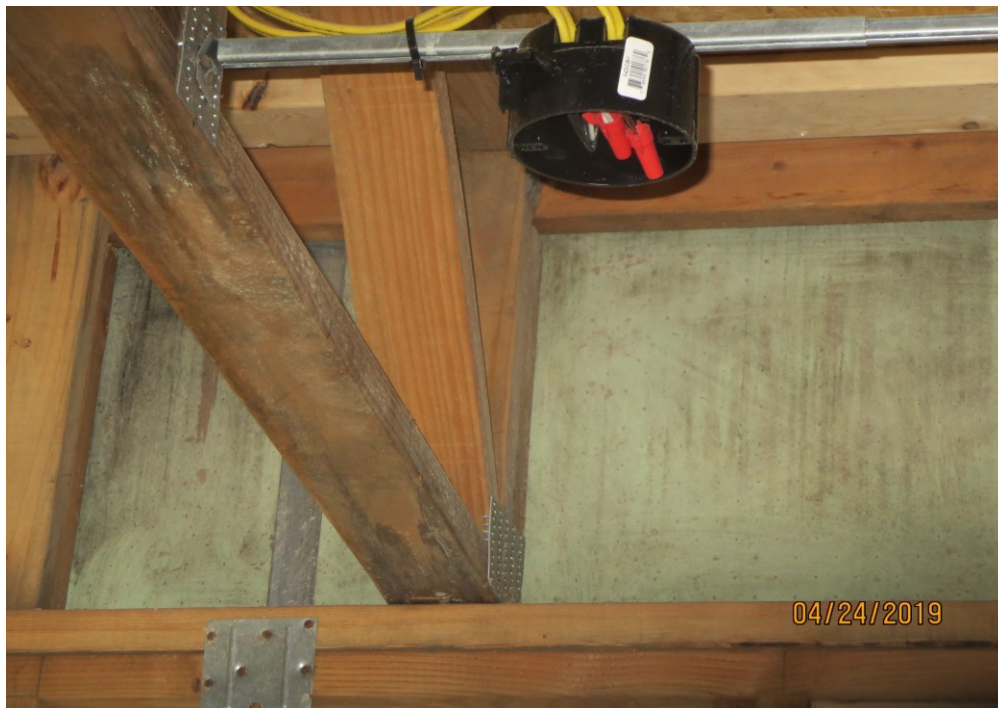
Typical water and soot damage Phase 4-5 intersection

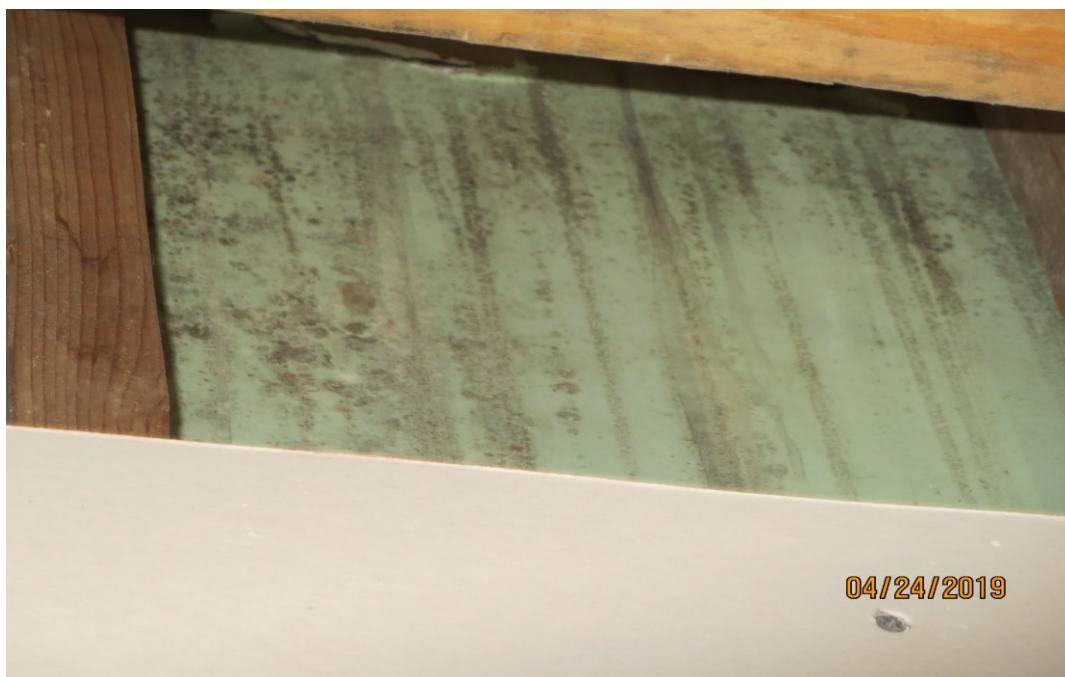
Typical water and soot damage Phase 4-5 intersection

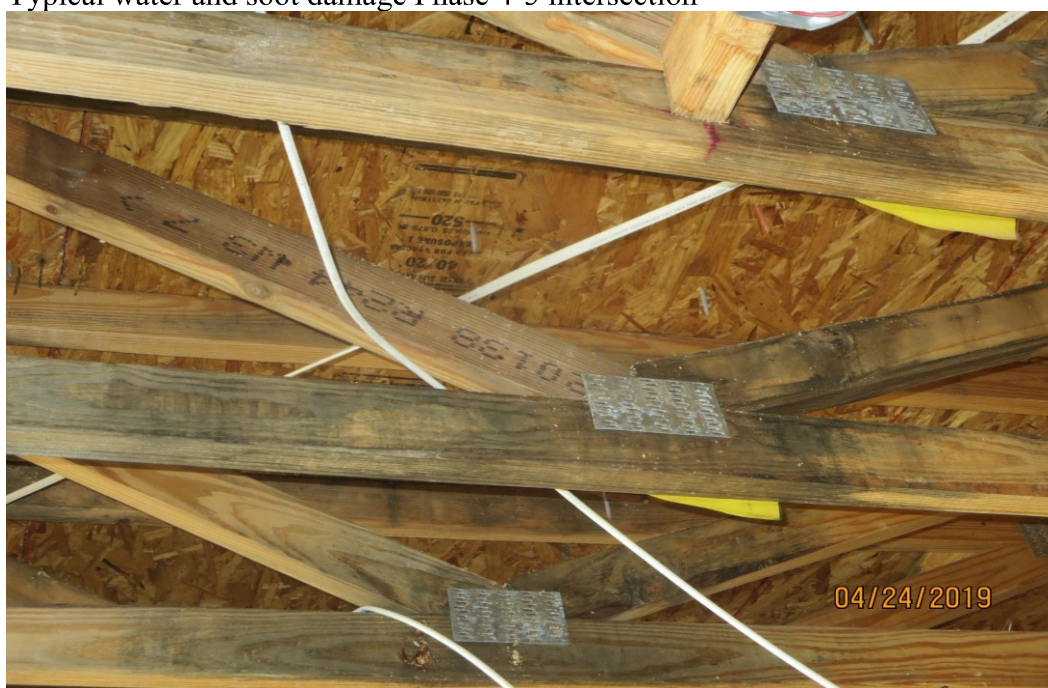
Typical water and soot damage Phase 4-5 intersection

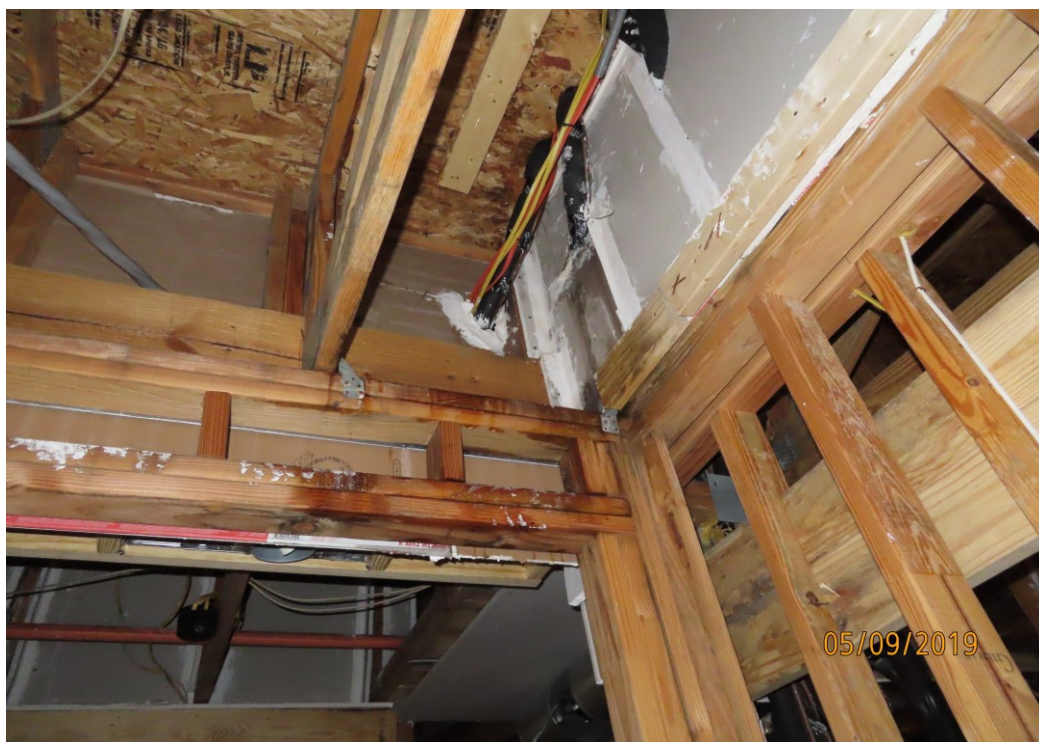
Active water during inspection from area where upper roof phase 4-was damaged by fire

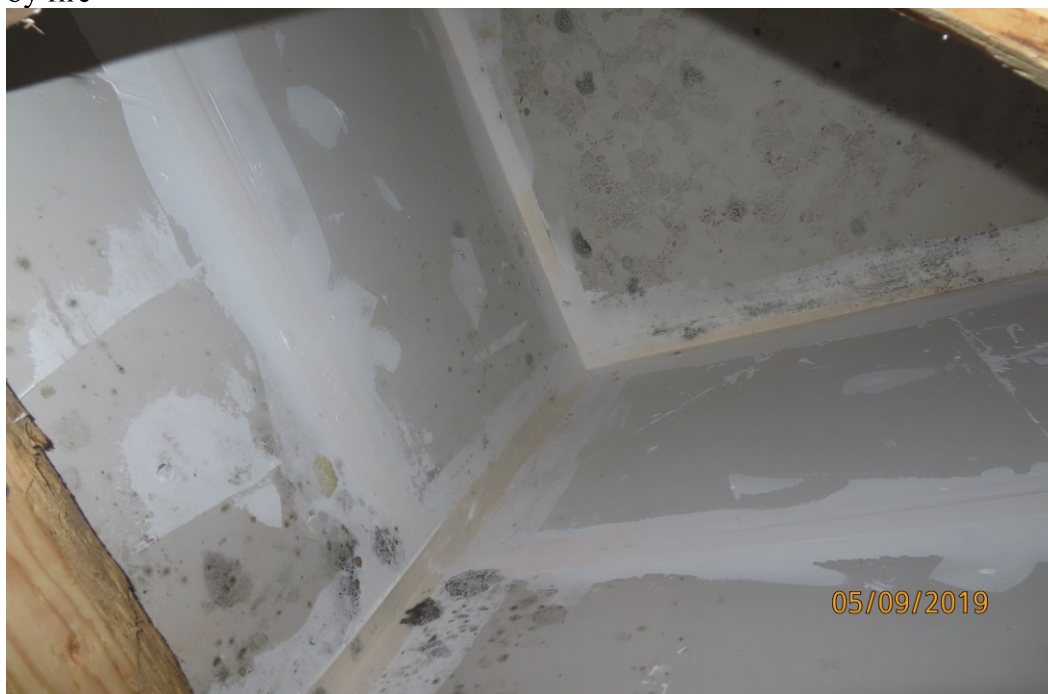
Phase 4 water damage

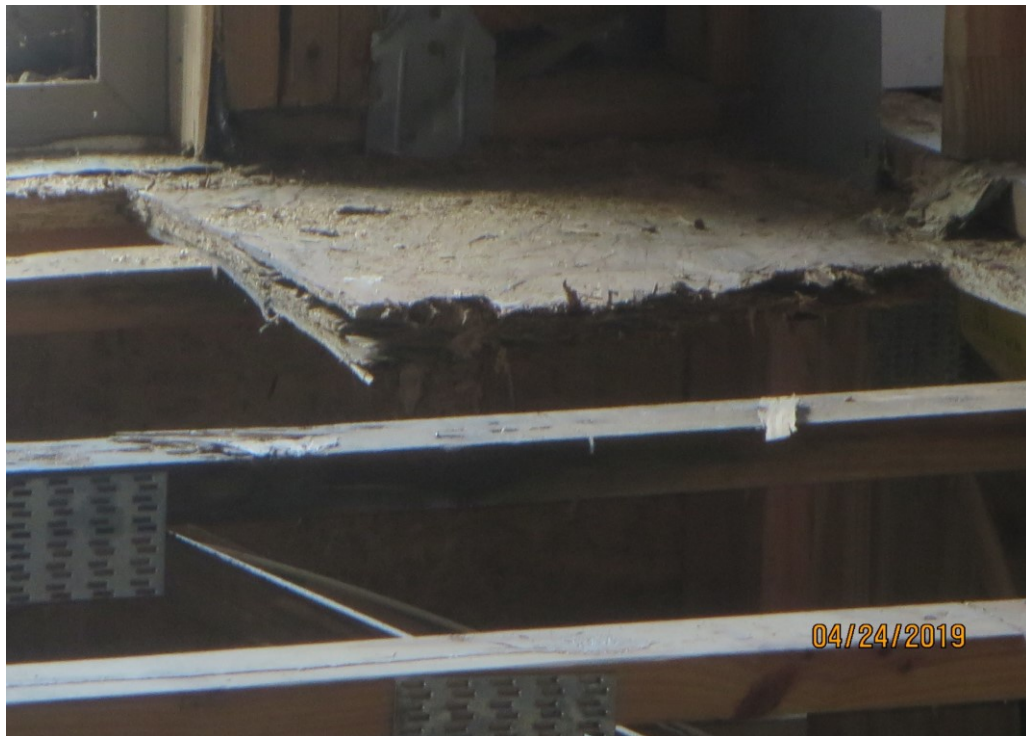
Typical subfloor condition phase 5. Subfloor under both partition and exterior walls must be removed and replaced.

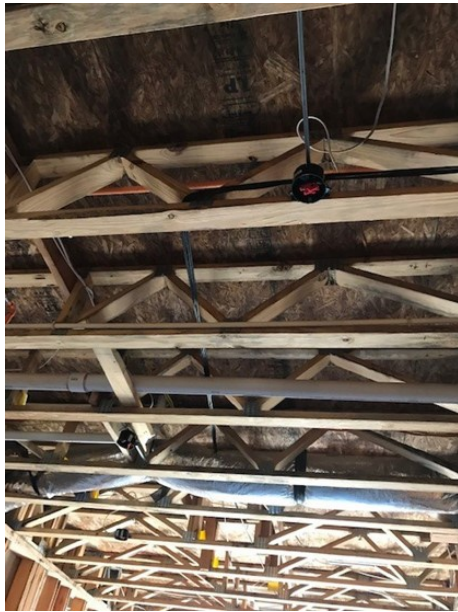
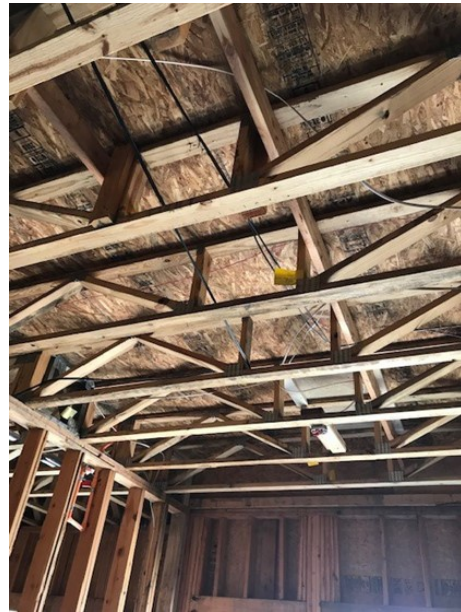
All water, fire-damaged, smoke and soot contaminated sheathing must be removed and replaced. All framing either cleaned, sealed or replaced. All framing modifications that have been made during the repair process (e.g. removed blocking, bracing, fire blocking and draft stopping) must be restored to a pre-loss condition.

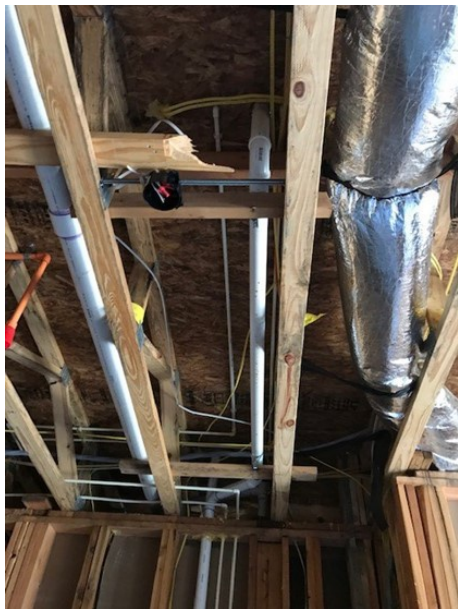
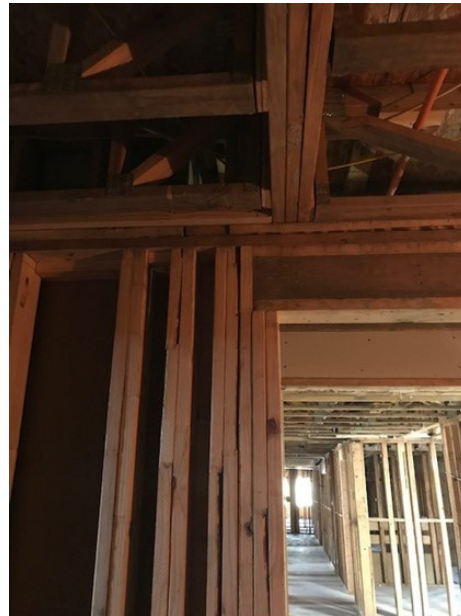
All framing either cleaned, sealed or replaced. All framing modifications that have been made during the repair process (e.g. removed blocking, bracing, fire blocking and draft stopping) must be restored to a pre-loss condition.

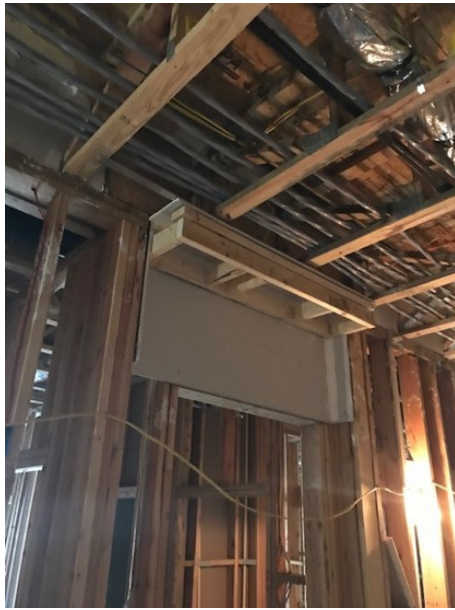
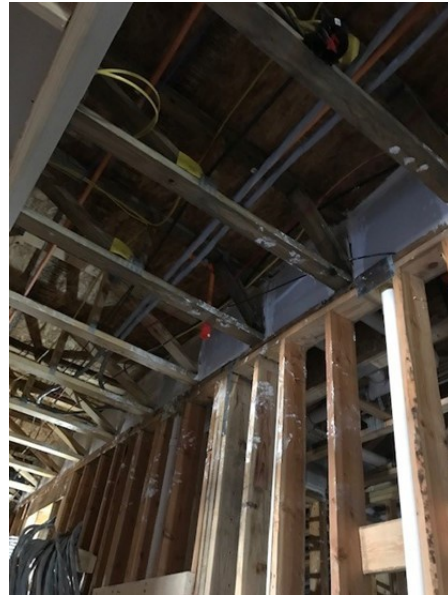
All framing either cleaned, sealed or replaced. All framing modifications that have been made during the repair process (e.g. removed blocking, bracing, fire blocking and draft stopping) must be restored to a pre-loss condition.

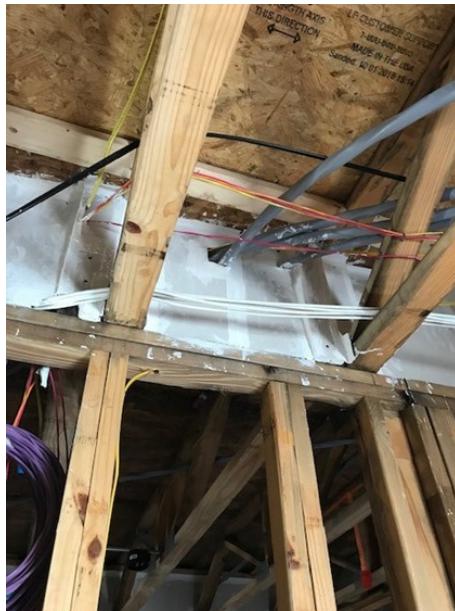
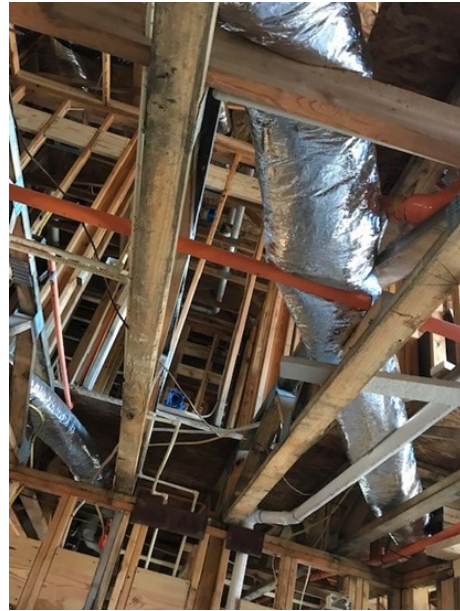
All remaining fire blocking and draft stopping elements must be assessed for reuse. Areas where pieces of sheetrock have been 'taped' in place, must be removed, and replaced. This will require removing all existing mechanicals for the drywall replacement. Once replacement has been done, then new penetrations reinstalled with code-compliant sealing around annular spaces.

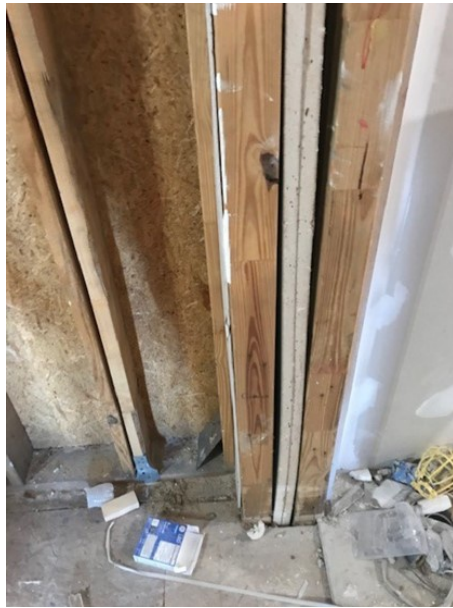
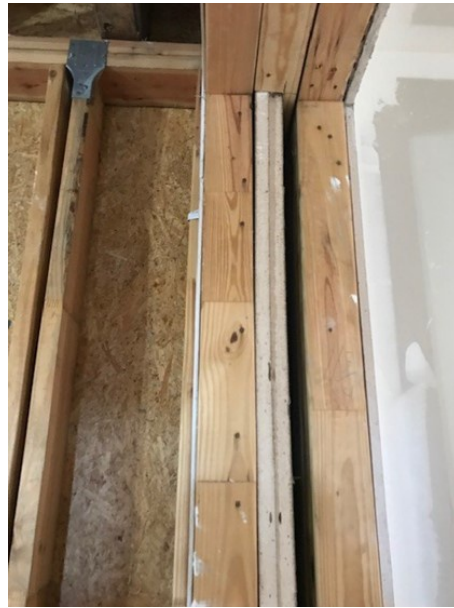
Fire walls have been damaged by the fire event. Framing has separated from the sheetrock that was part of the fire wall assembly. To regain code-compliance, these walls must be removed and rebuilt with all layers and fasteners inspected by the municipal building inspectors to verify compliance with their corresponding design selection from the Gypsum Association (including STC ratings).

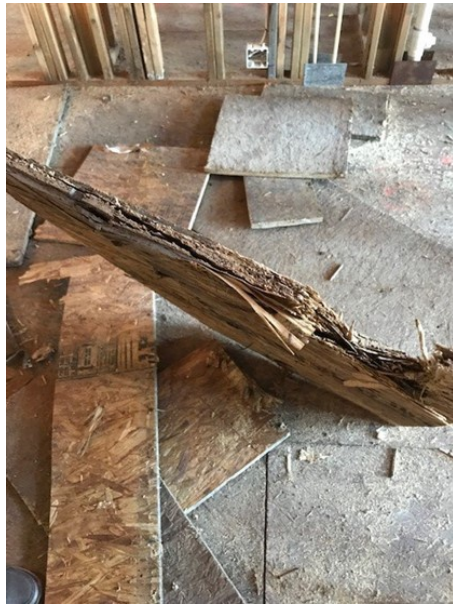
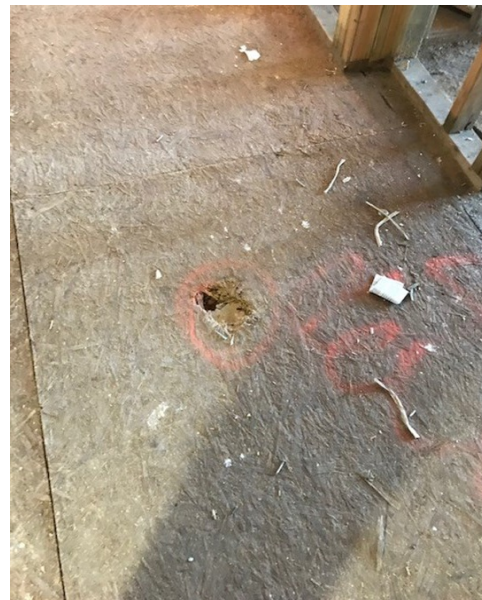
Exposure to massive amounts of water during the ‘surround and drown’ method of protecting the remaining buildings without corresponding drying of the framing has caused systemic delamination in the OSB floor assemblies. Weight of individuals applied to the floor system causes failure resulting in people’s feet going through the floor.

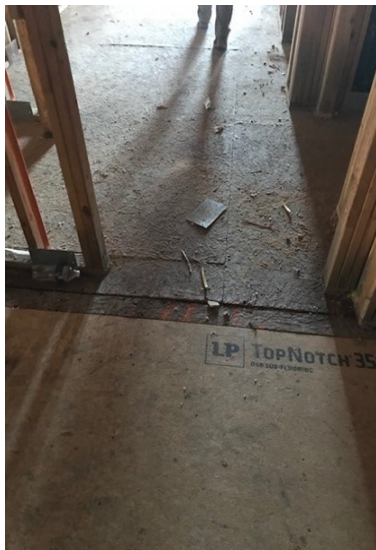
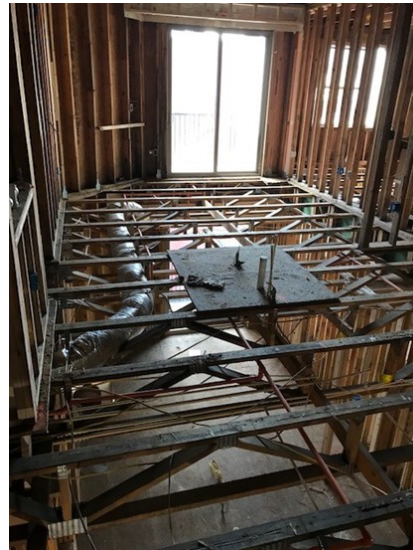
Replacement of subfloor must be corner to corner. This may be achieved by installation of continuous shoring, jacking up walls to separate from floor systems, remove the damaged floor sheathing, sliding new floor sheathing under the walls, floor by floor. All work should be done under the supervision of a structural engineer. This will require removal of exterior siding, windows and sheathing. Removal of mechanical and electrical will be required depending on location. [See Phase 5 preliminary scope of repairs below]

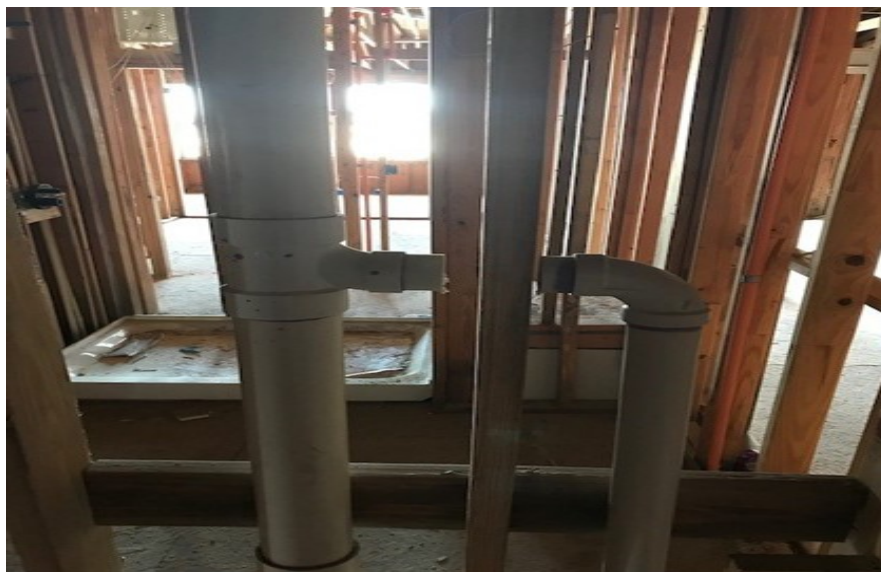
Mechanicals affected by framing repairs must be inspected by municipal building inspectors to ensure that there are no further life/safety violations that could result in further damage to the structure. This will require air tests on the drain, waste, and vent elements of the plumbing system, and inspection of the electrical systems throughout the building.

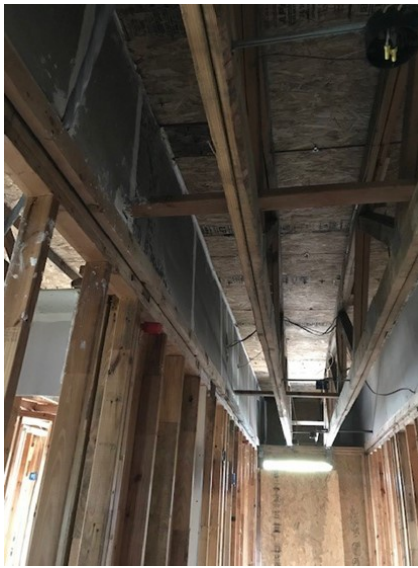
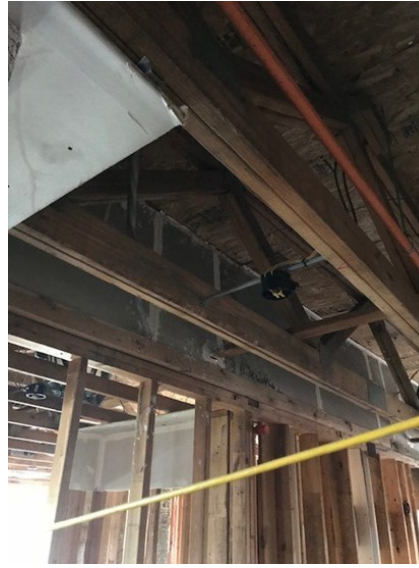
The corridors leading to the skyway must have all the water and fire-damaged, smoke, and soot damaged material removed and replaced.

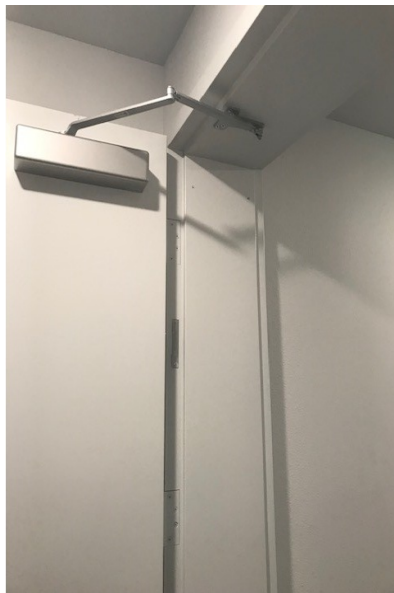
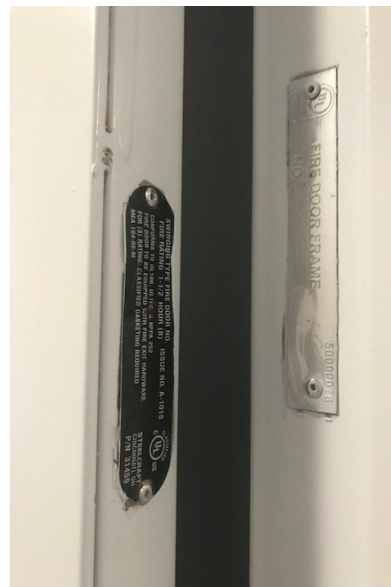
Repairs in the corridor resulted in the smoke gaskets being stripped from the doors in the rated fire walls. Gaskets from the door manufacturer must be reinstalled in all fire-rated door assemblies.

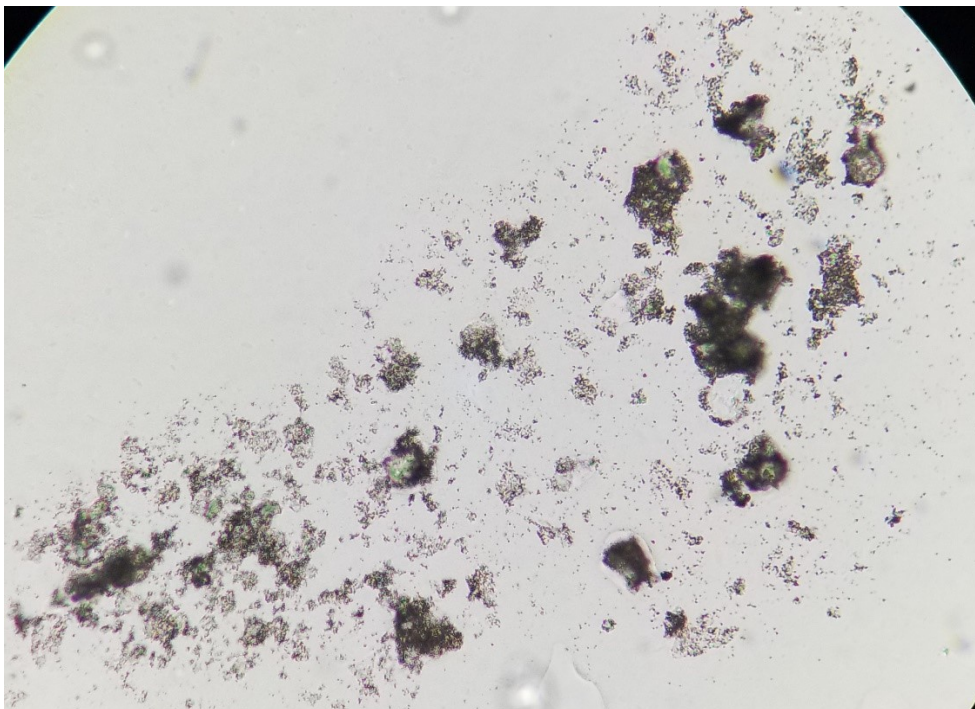
#12 Char-like particles

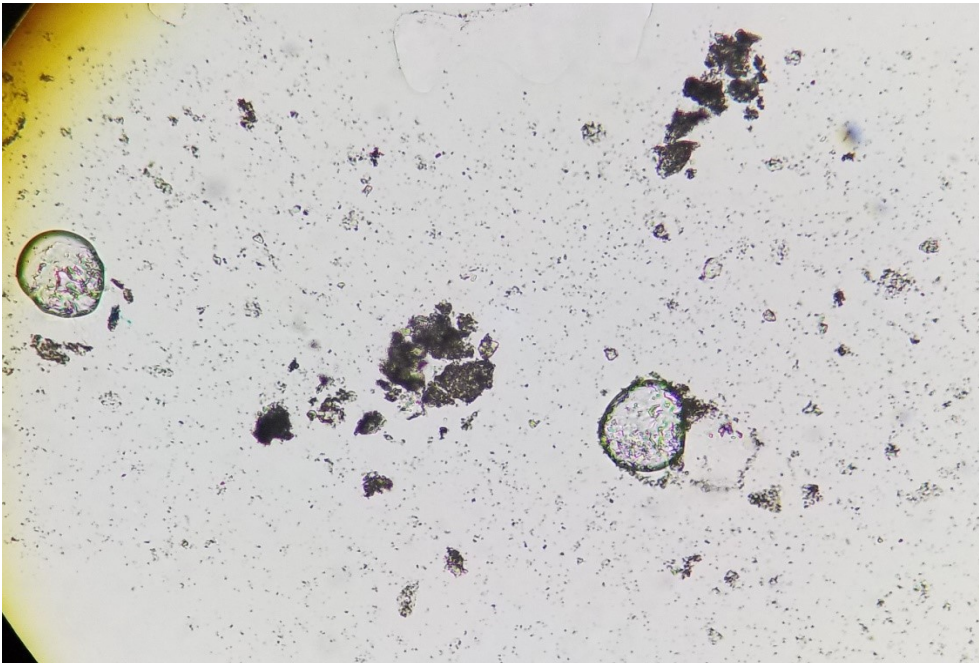
#14 Soot-like particles

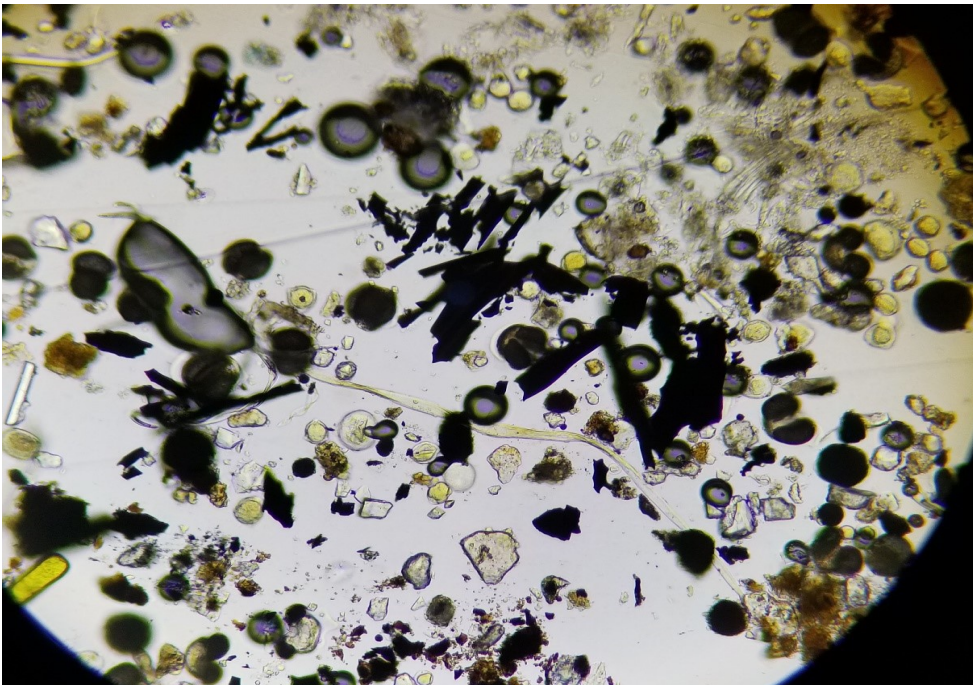
#46 Char-like particles and pollen spores

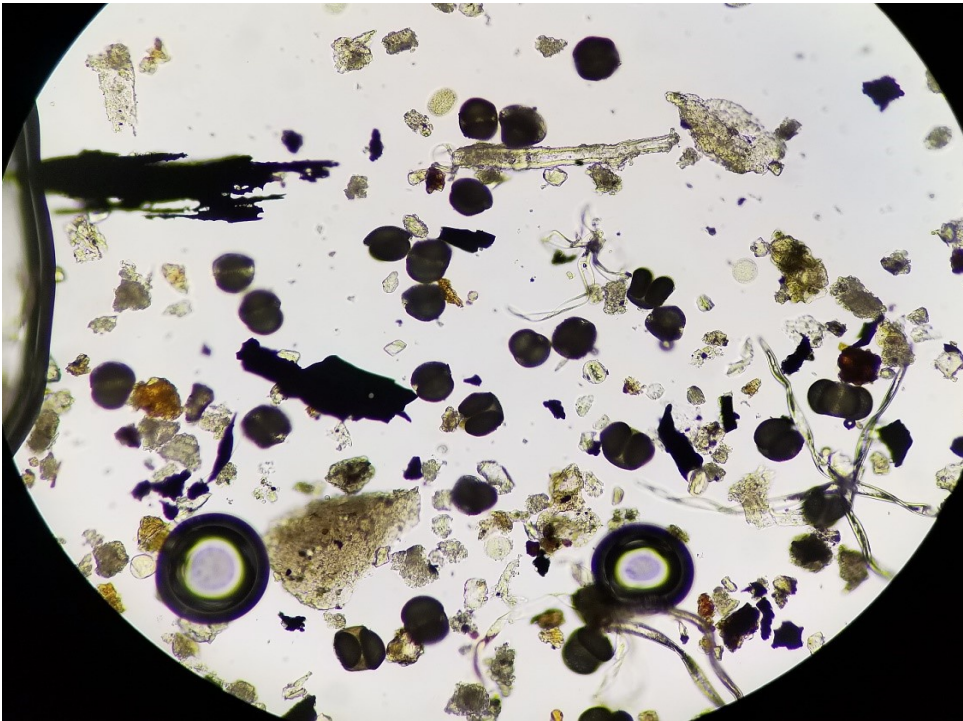
#48 Char-like particles and pine pollen

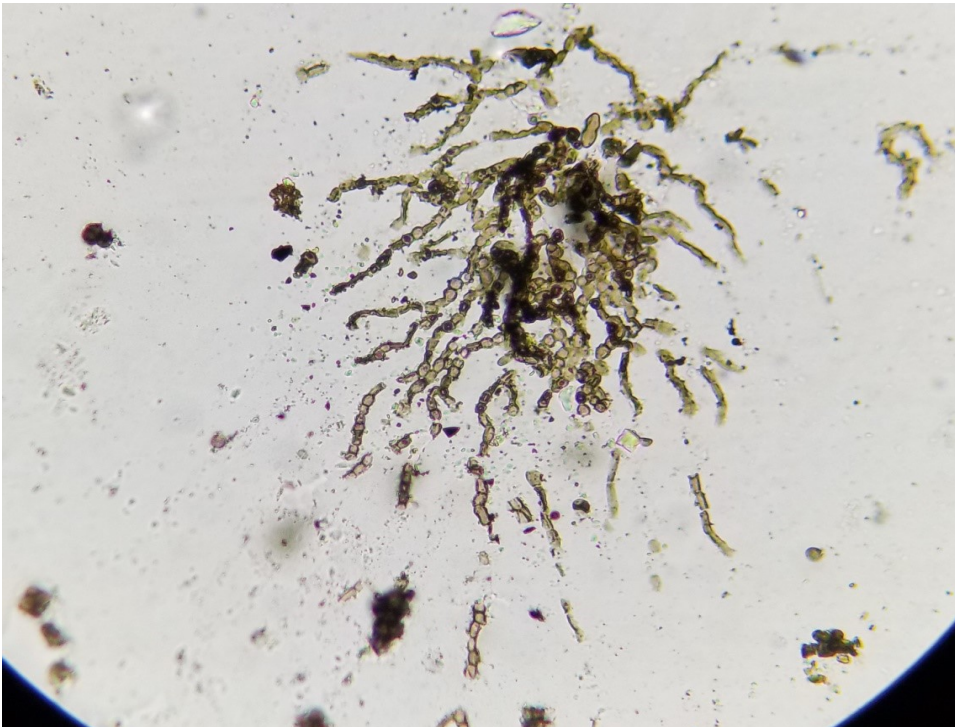
#50 Tease tape – Fungal growth – Soot-like particles
